Penalty box

Krems prison yard

BIG - Bundesimmobiliengesellschaft mbH, trafo.K

GABU Heindl Architektur
Schottenfeldgasse 72/2/8
A-1070 Wien
www.gabuheindl.at

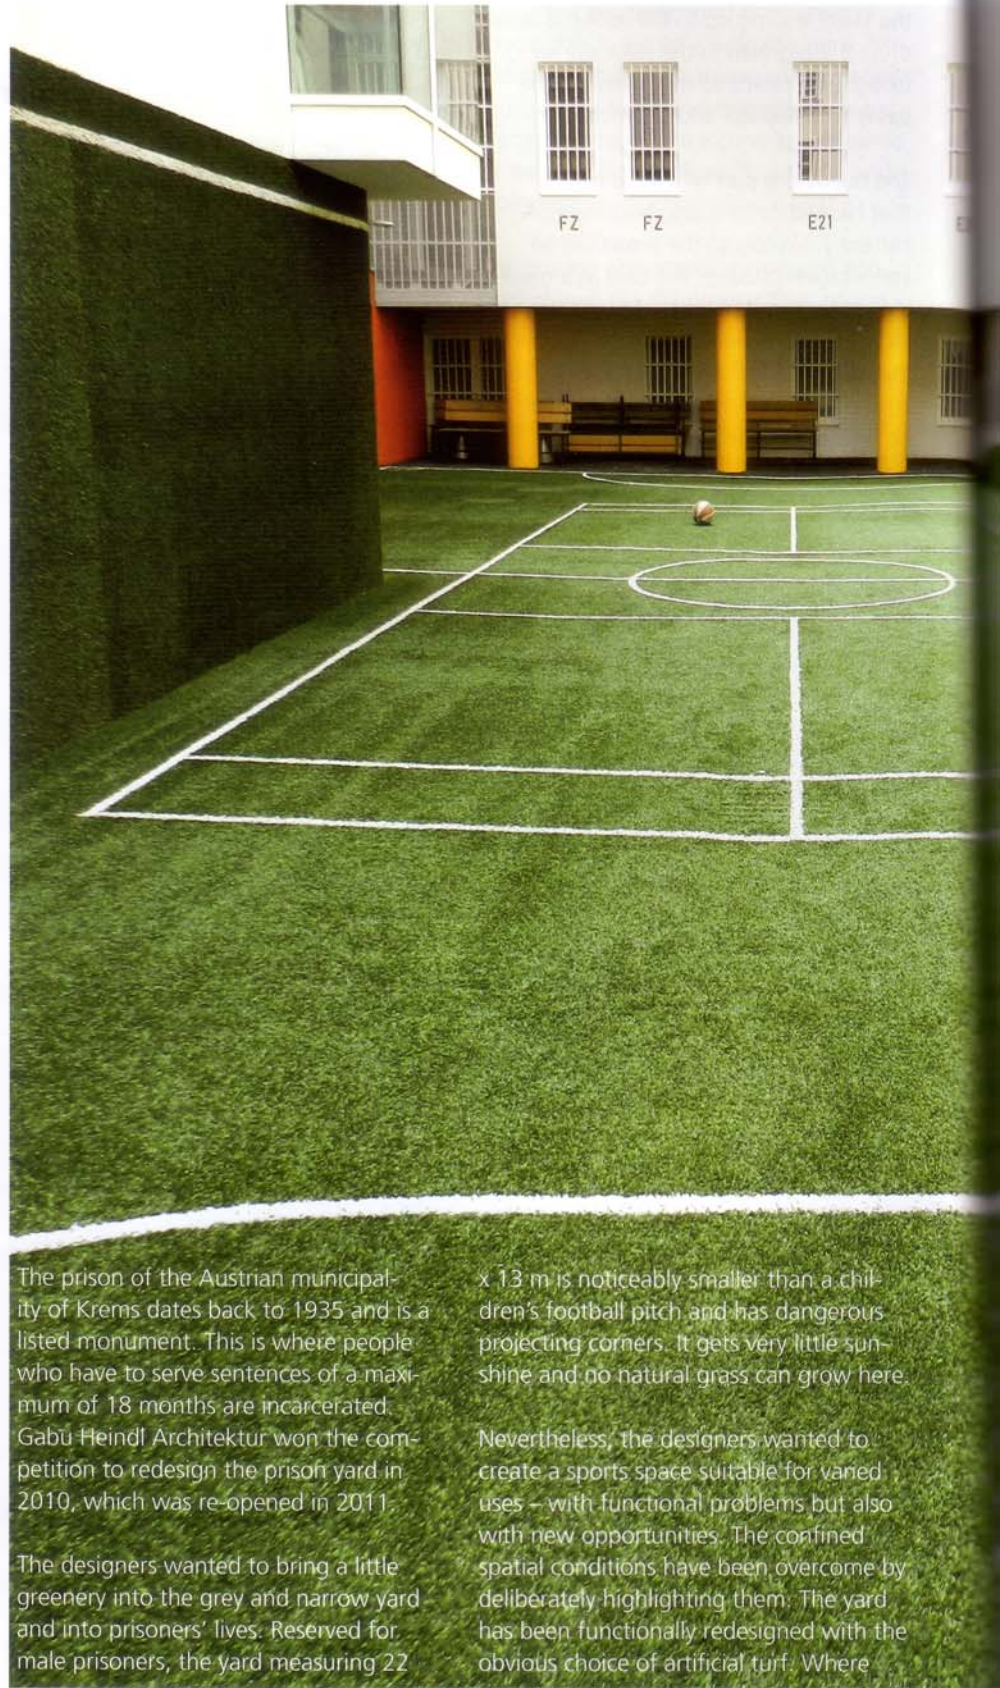
The designers wanted to bring a little greenery into the grey and narrow yard and into prisoners' lives. Reserved for male prisoners, the yard measuring 22

x 13 m is noticeably smaller than a children's football pitch and has dangerous projecting corners. It gets very little sunshine and no natural grass can grow here.

Nevertheless, the designers wanted to create a sports space suitable for varied uses – with functional problems but also with new opportunities. The confined spatial conditions have been overcome by deliberately highlighting them. The yard has been functionally redesigned with the obvious choice of artificial turf. Where

the building's outer walls encroach on the pitch, the turf surface is simply folded up the wall and serves as impact protection. Steps along the edge become a spectator terrace and the artificial turf cushioned seating.

In confined space, a unique multifunctional space has thus been created with pitches/courts for indoor football, basketball and badminton and standing/seating for users and spectators. The spectator terrace even occasionally catches the sun.
